Isle of Wight Council  
**Eastern Yar River Restoration  
Plan**  
Final Report

For Issue | 27 January 2015

Job number 239428-00

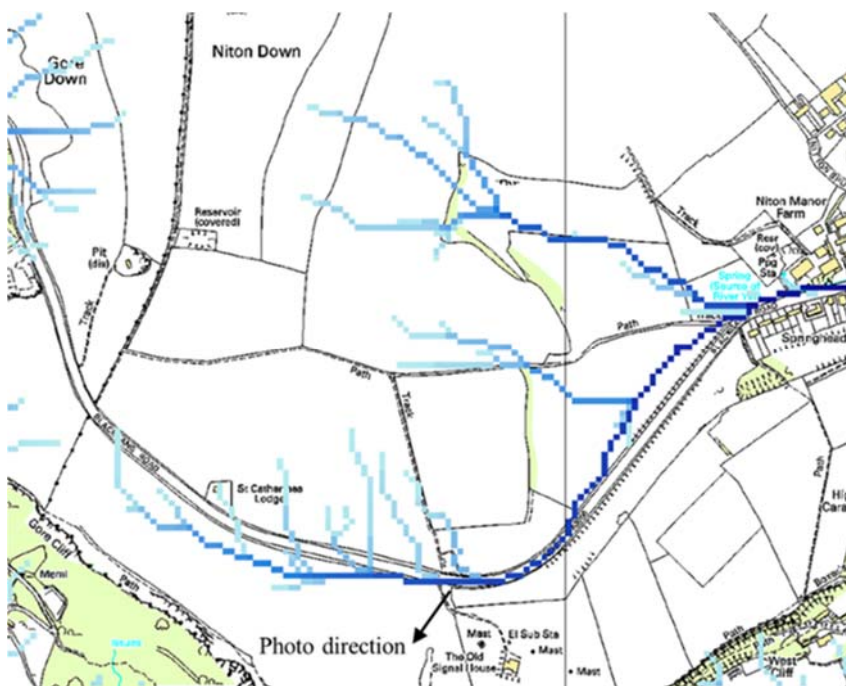
The Eastern Yar catchment is predominantly agricultural, especially in the uplands. It was noted that, during the catchment walkover, surface runoff was observed in many of the agricultural areas of the catchment as illustrated in Figure 6, which shows a relatively newly-sown arable field.

Figure 6: a) Example of runoff from agricultural field near Niton; b) GIS analysis of topography of area in photo – showing area as prone to surface runoff.

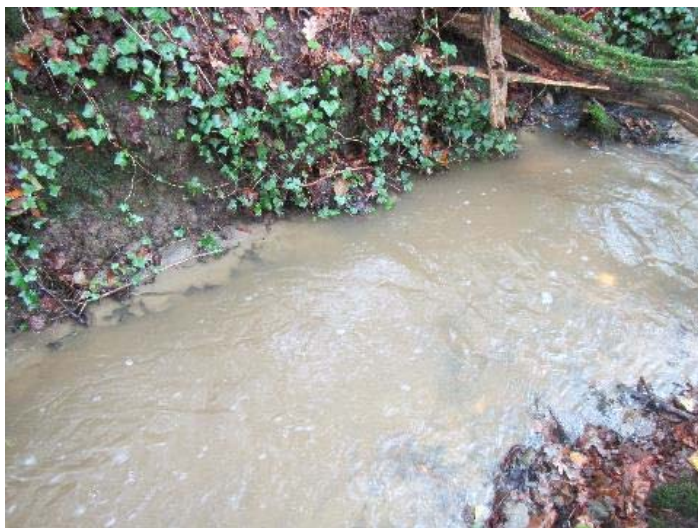
The presence of fine sediment in the water column can affect the aquatic environment in a number of ways. An increase in turbidity reduces light penetration and silt deposition modifies the substrate of the river bed (e.g. Kemp *et al.*, 2011, Jones *et al.*, 2012a and 2012b) (Figure 7). These effects in turn can have deleterious effects upon the flora and fauna present within the watercourse, reducing habitat suitability, disturbing communities/populations or causing direct harm to individual species. It has also has implications for water quality as discussed in Section 5.7.

Figure 7: Excess siltation on river bed (Scotchells Brook)

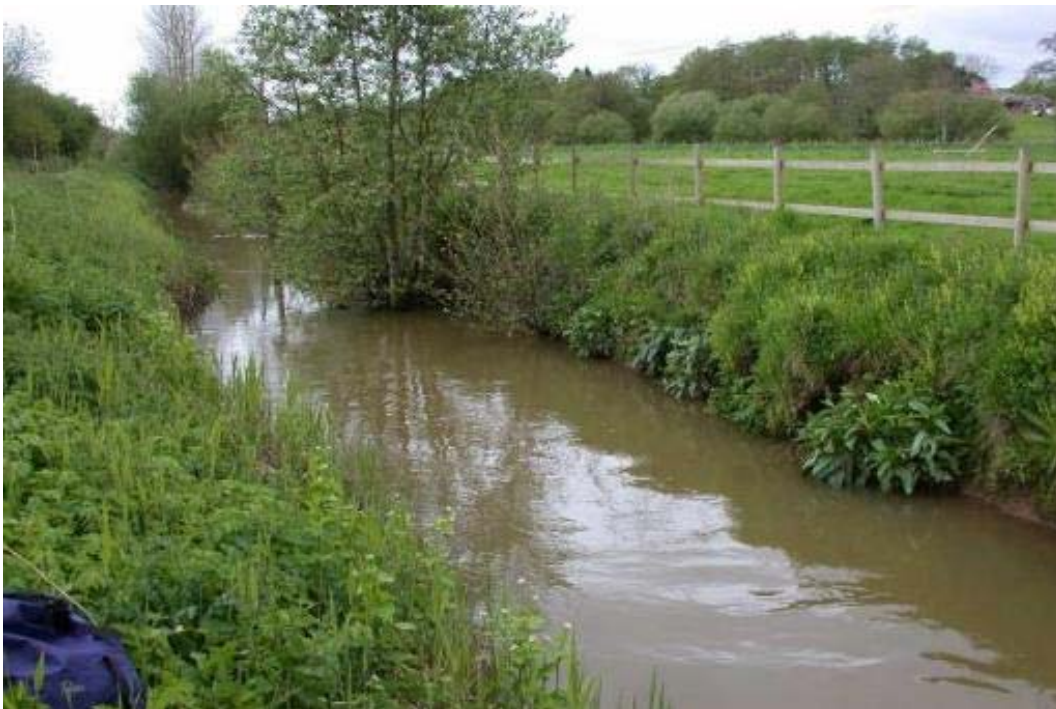
The result of these historical modification has been a loss of natural structure in the watercourse and reduction in the diversity of habitats present. Niche habitats for particular flora and fauna are likely to have been lost. As a result, communities will typically comprise lower species diversity made.

Figure 8: Low diversity in river channel (Lower Eastern Yar – downstream of Horryngford Bridge)

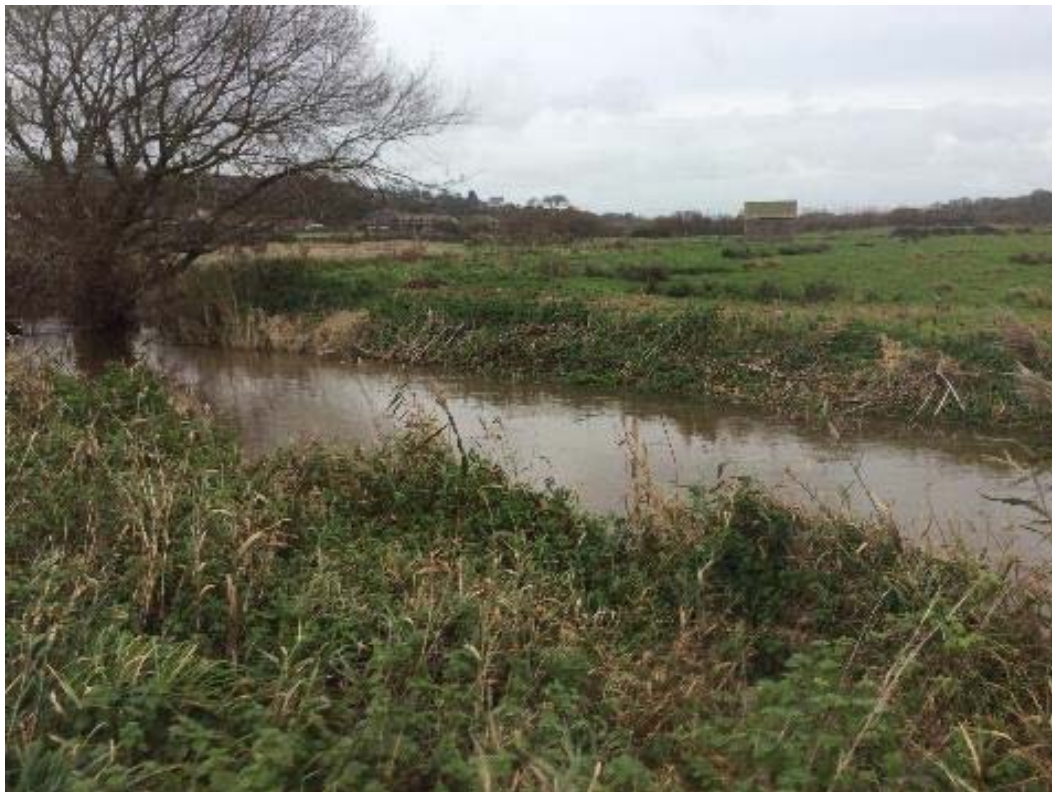
Increased conveyance in these channels, which increases flood risk to downstream areas, also means that the local floodplain floods less often. This has implications for soil moisture levels, but also limits sediment and nutrient delivery to the floodplain locally. Floodplain interaction is important for wetland habitat and the grazing marshes like Brading Marsh and the area downstream of Morton as shown in Figure 9. Benefits of controlled improved connectivity would thus include improved natural processes and habitats and potential reduction of flooding pressures in other areas, both rural and urban. Any proposals would need appropriate consultation with landowners and stakeholders and assessment of socio-economic, flood risk and ecological implications.

Figure 9: Large area of disconnected floodplain near Morton

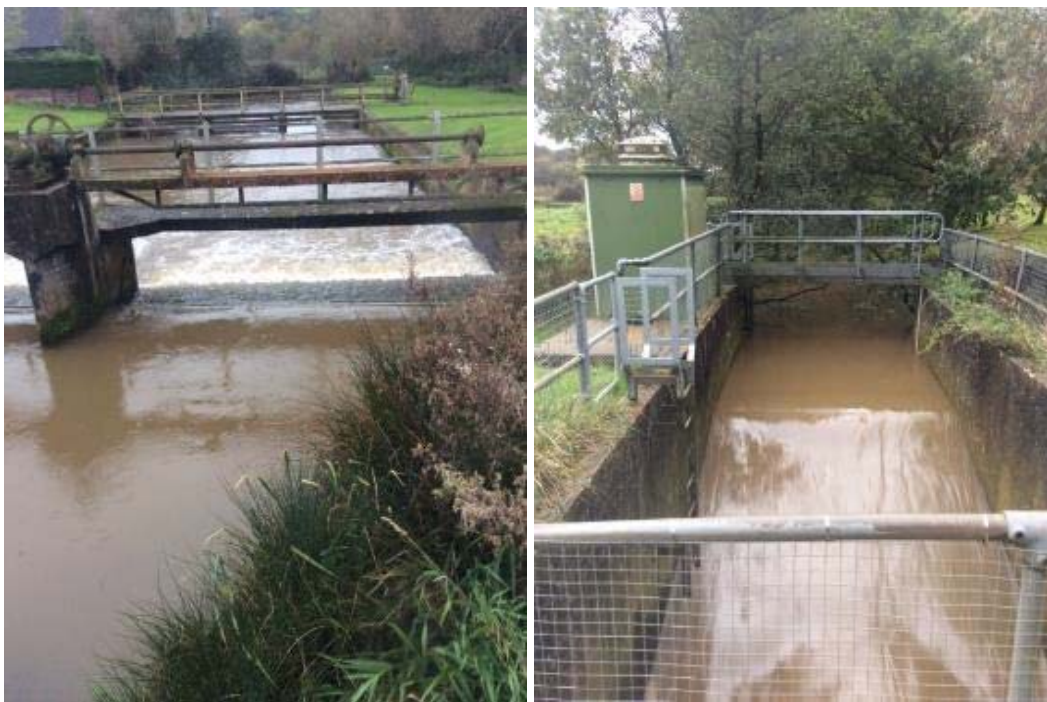
Several barriers have been identified on the geomorphological survey (see Figure 10, Figure 11 and Table 5). Although some of these barriers may be obsolete, others like Budbridge gauging sluice, or the Great Sluice and Bembridge Sluice, are still in use, and any intervention or modification will need to take this into consideration

Figure 11: Example barriers to fish passage (Left - Alverstone Mill Sluice, Right - Budbridge gauging station).

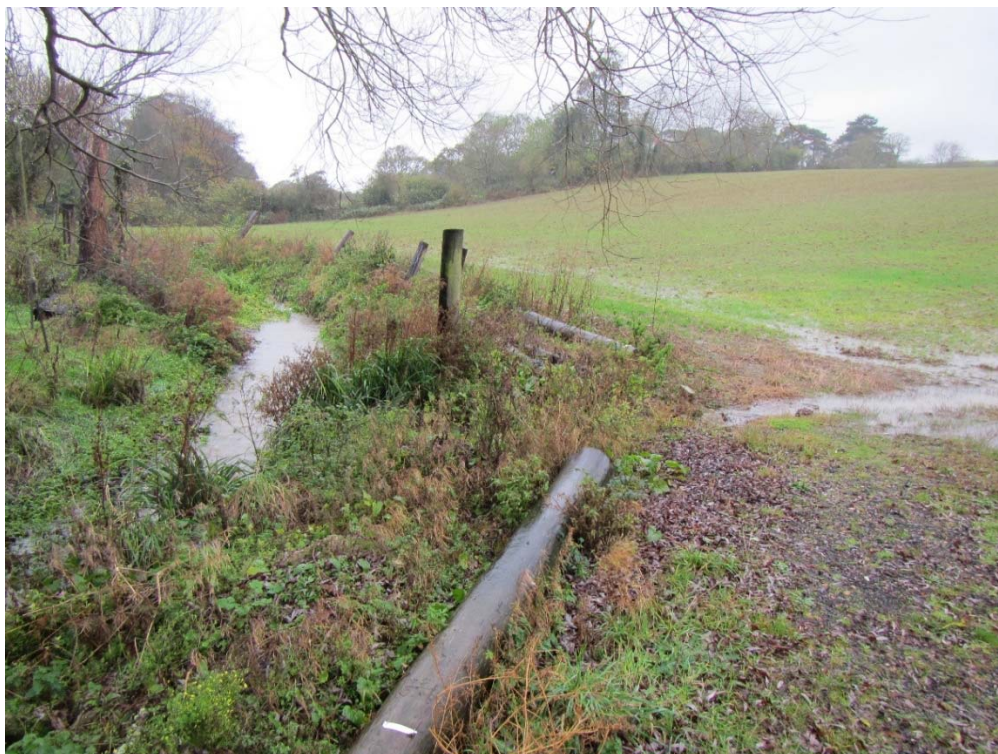
Figure 14: Arable field near Southford Lane discharging runoff directly into Upper Eastern Yar

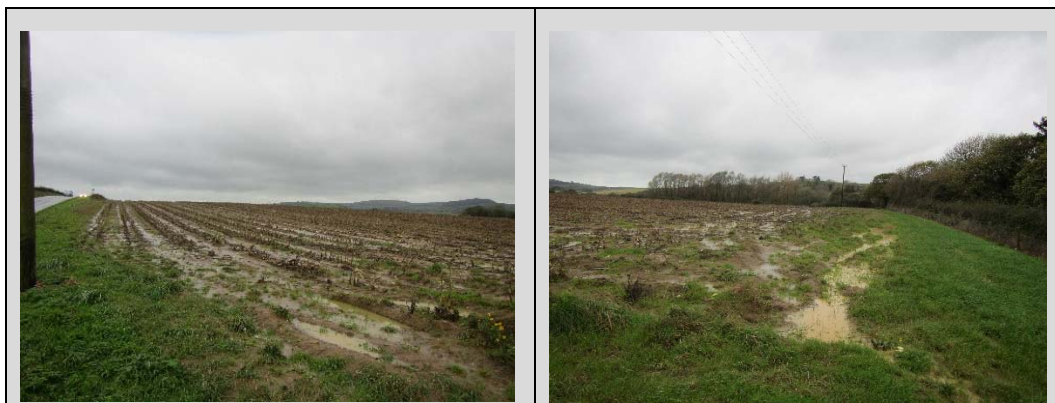
The catchment walkover showed that agricultural land surrounding the river is contributing significant amounts of runoff and associated sediments into the drain and river network (see Figure 18). The 2013 EA report also identifies sediment input into the river from surrounding fields in this area. Some sediment input is also coming from bank erosion and channel bed incision. These fine sediments can contribute to the deterioration of morphological quality and aquatic habitat condition of the system.

Figure 18: Left – Arable fields discharging runoff in the Whitwell area

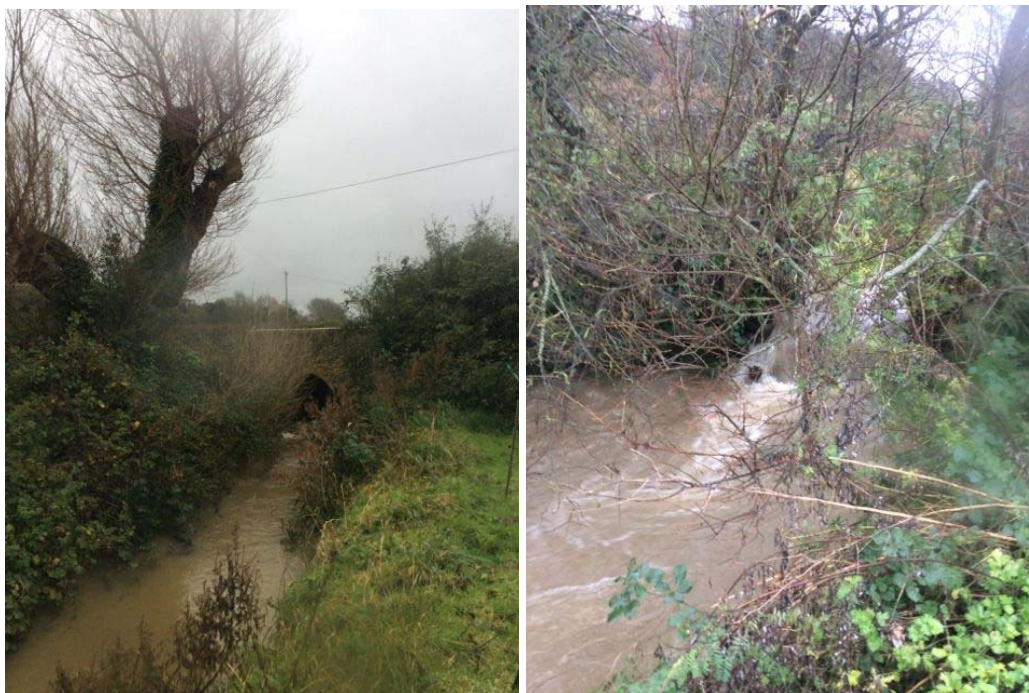
The channel becomes wider in this section, with relatively diverse flows including runs and some small poorly formed riffles. Several small ditches and one larger tributary drain into this reach. As mentioned above the channel planform in this area is more sinuous than the OS maps show. Although there are some short sections where the channel is trapezoidal, with near vertical banks there are also more asymmetrical parts where different erosional and depositional processes are taking place. There is evidence of some incision and also some fluvial erosion on the right bank in a few places.

Figure 19: General view of Reach 2 and weir in the lower half of the reach

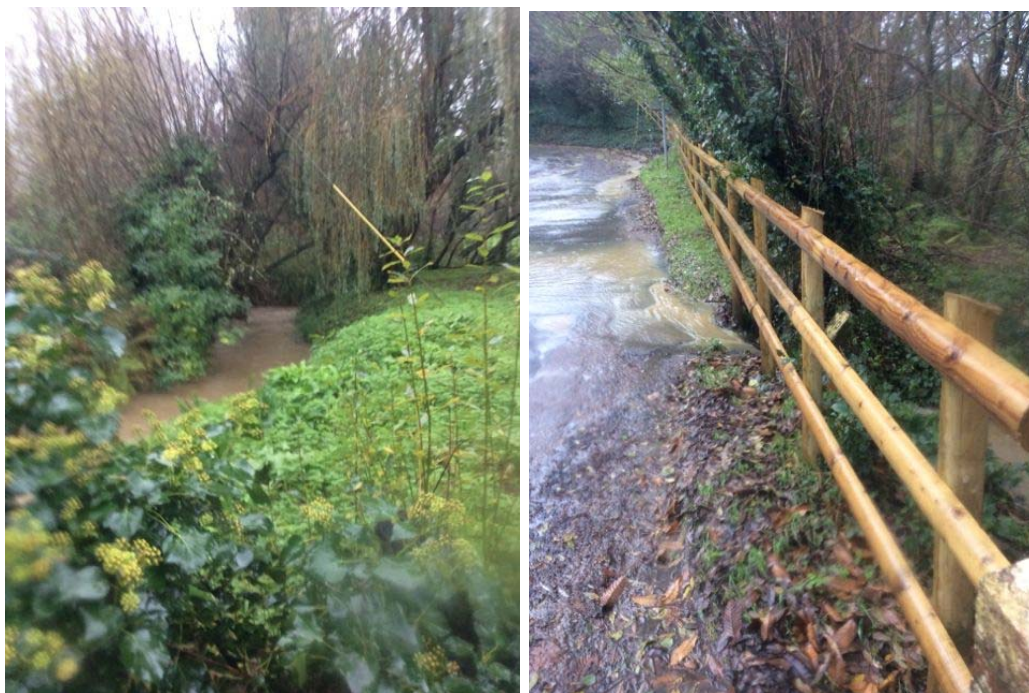
Road runoff was observed draining directly onto the river at the bridge on the downstream end of the section. This could have an impact on water and sediment delivery downstream, but also potentially on water quality due to the input of runoff and road associated pollutants.

Figure 22: Reach 5 and road runoff discharging into river.

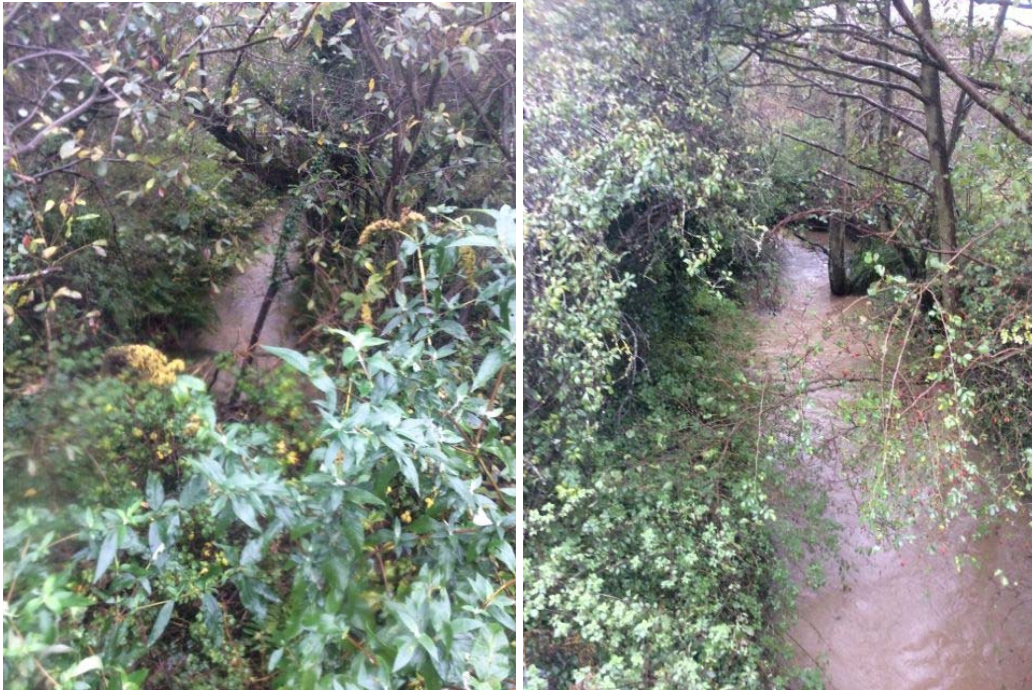
There is dense riparian vegetation composed mostly of scrub and trees, which are encroaching the channel in places. This heavily vegetated area provides a natural buffer between the river and arable land on both sides, and can also provide shade and shelter to aquatic species. Habitats may be negatively affected, however, where the vegetation is encroaching the channel due to impact on marginal habitats.

Figure 24: Reach 7 showing encroaching vegetation

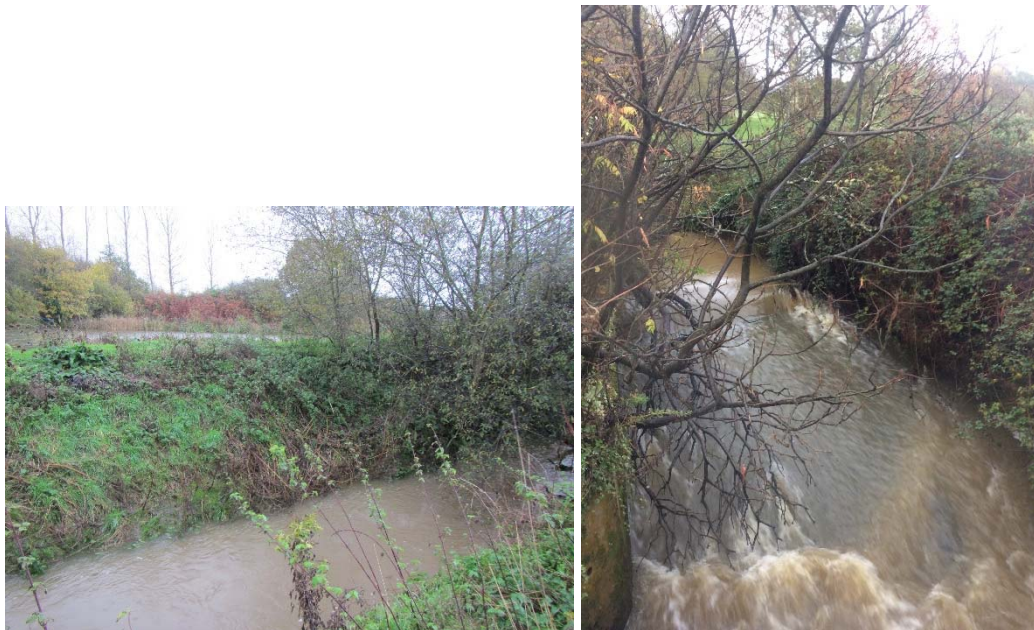
The channel is trapezoidal and in-channel diversity is low. Coverage of bank vegetation is thinner than in upstream reaches, with sparse tree cover (approximately 15%). There is artificial bank protection in places along the reach, some linked to housing and its associated infrastructure.

Figure 35: Reach 11 and Horringford Bridge weir

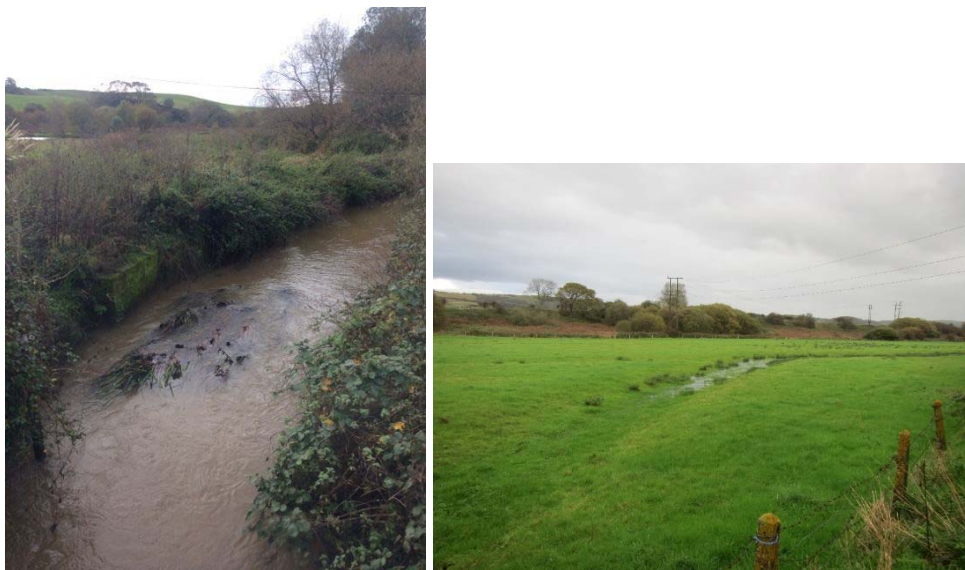
The trapezoidal channel in this reach is embanked and heavily incised due to historical straightening and dredging. These modifications have led to a loss in morphological diversity and floodplain connectivity, as reported as well by the EA geomorphic walkover (Environment Agency, 2014). The banks are composed of cohesive fine material, with evidence of erosion and undercutting near the toe, suggesting that the river is trying to adjust its morphology to a more natural form. There is some erosion on the outside of bends where the river is more sinuous, and also some depositional features such as mid-channel bars.

Figure 36: Reach 12 and line of former channel on floodplain

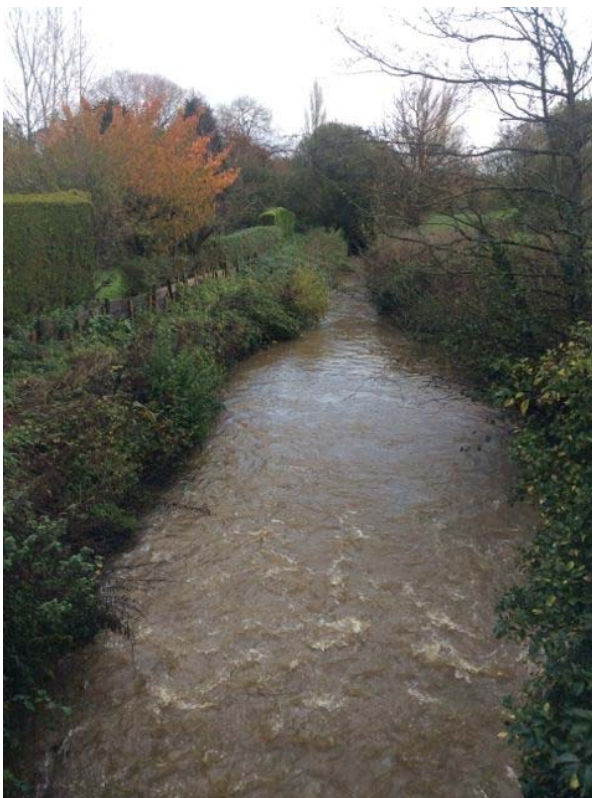
Figure 37: Reach 13

Within this reach the banks are steep, and the channel form is trapezoidal and incised with embankments from dredging with low in-channel diversity and uniform flow. The central section is very sinuous, although the uniform channel shape prevents a diverse system from developing. The right bank is dominated by herbaceous vegetation and shrubs, with some sparse trees also on the left bank. There are some areas with little riparian vegetation cover where bank erosion can be observed. There is a high silt load, and the bed could not be seen either at the time of the EA walkover in September 2014 (Environment Agency, 2014). There is some gravel in the substrate, but it is mostly dominated by fine sediments.

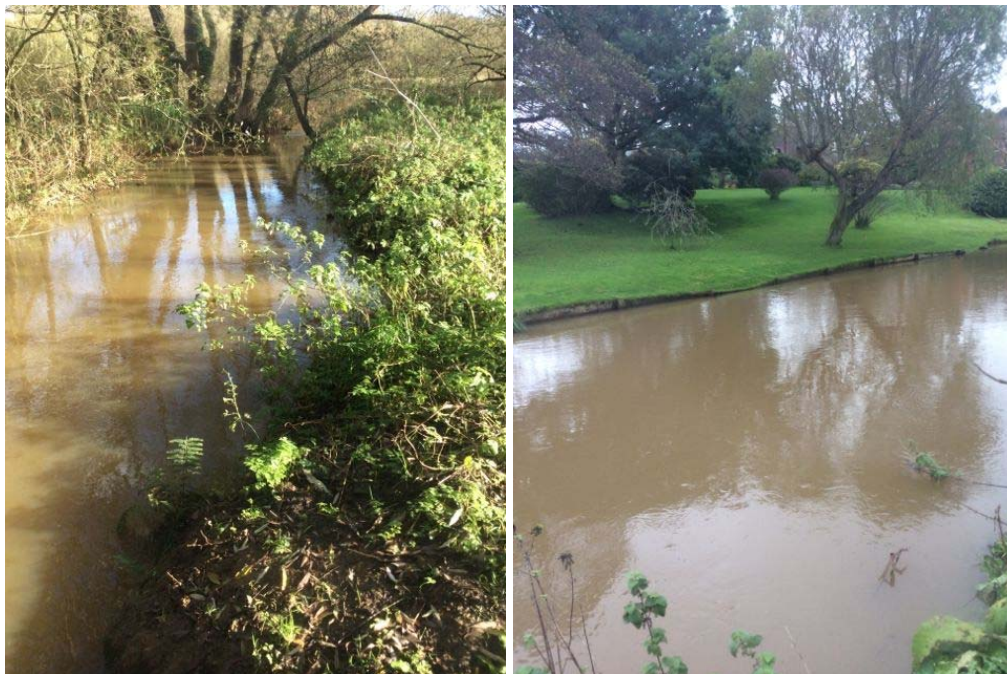
This reach is impacted by the ponding effect of the sluice at Alverstone Mill. Although riparian vegetation is fairly dense in the upstream section of the reach, it becomes relative sparse nearer the sluice. The channel shape is mostly trapezoidal with very little morphological diversity, although there is a more asymmetrical section in the upstream part of the reach. There is a path that runs parallel to the channel, with evidence of bank erosion from walkers/dogs, and embankments on part of the section.

Figure 38: Reach 14, ponded reach upstream of Alverstone Mill

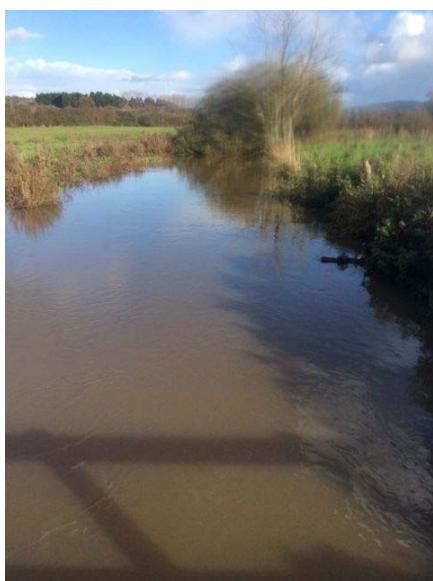
Figure 39: Reach 15

Substrate silt thickness was measured at some spot sampling points located near the bank toes up to 0.20 m, and at some points presence of some gravel was also noted.

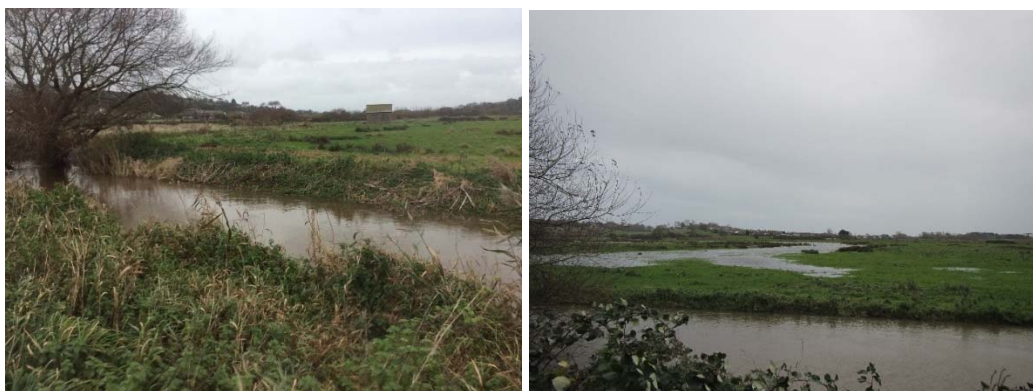
In some areas, the loss of the active floodplain is leading to the establishment of scrub which can encroach into the channel and wetland areas result in loss of valuable habitats.

Figure 41: Reach 16 and abandoned meander in Brading Marshes

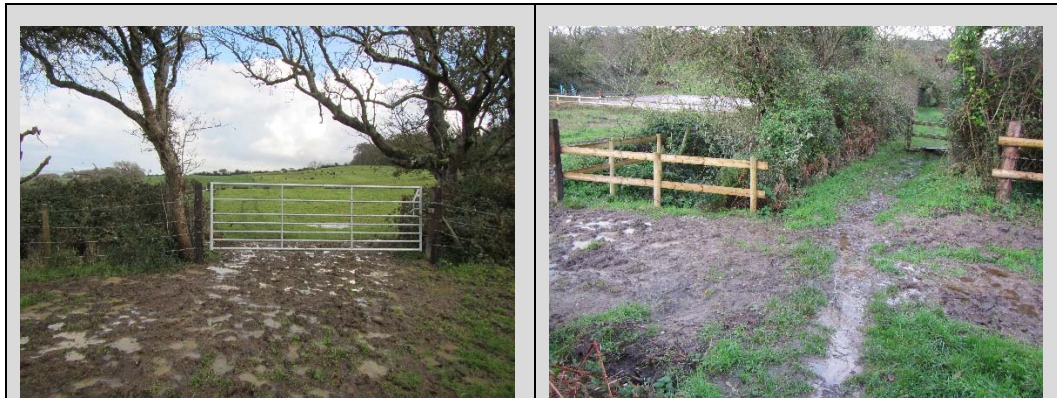
Figure 44: Left – Poaching at entrance to field in upper Scotchells Brook sub-catchment; Right – Poaching at livestock crossing point upstream of Apsecastle Wood
