Isle of Wight Council  
**Eastern Yar River Restoration  
Plan**  
Final Report

For Issue | 27 January 2015

Job number 239428-00

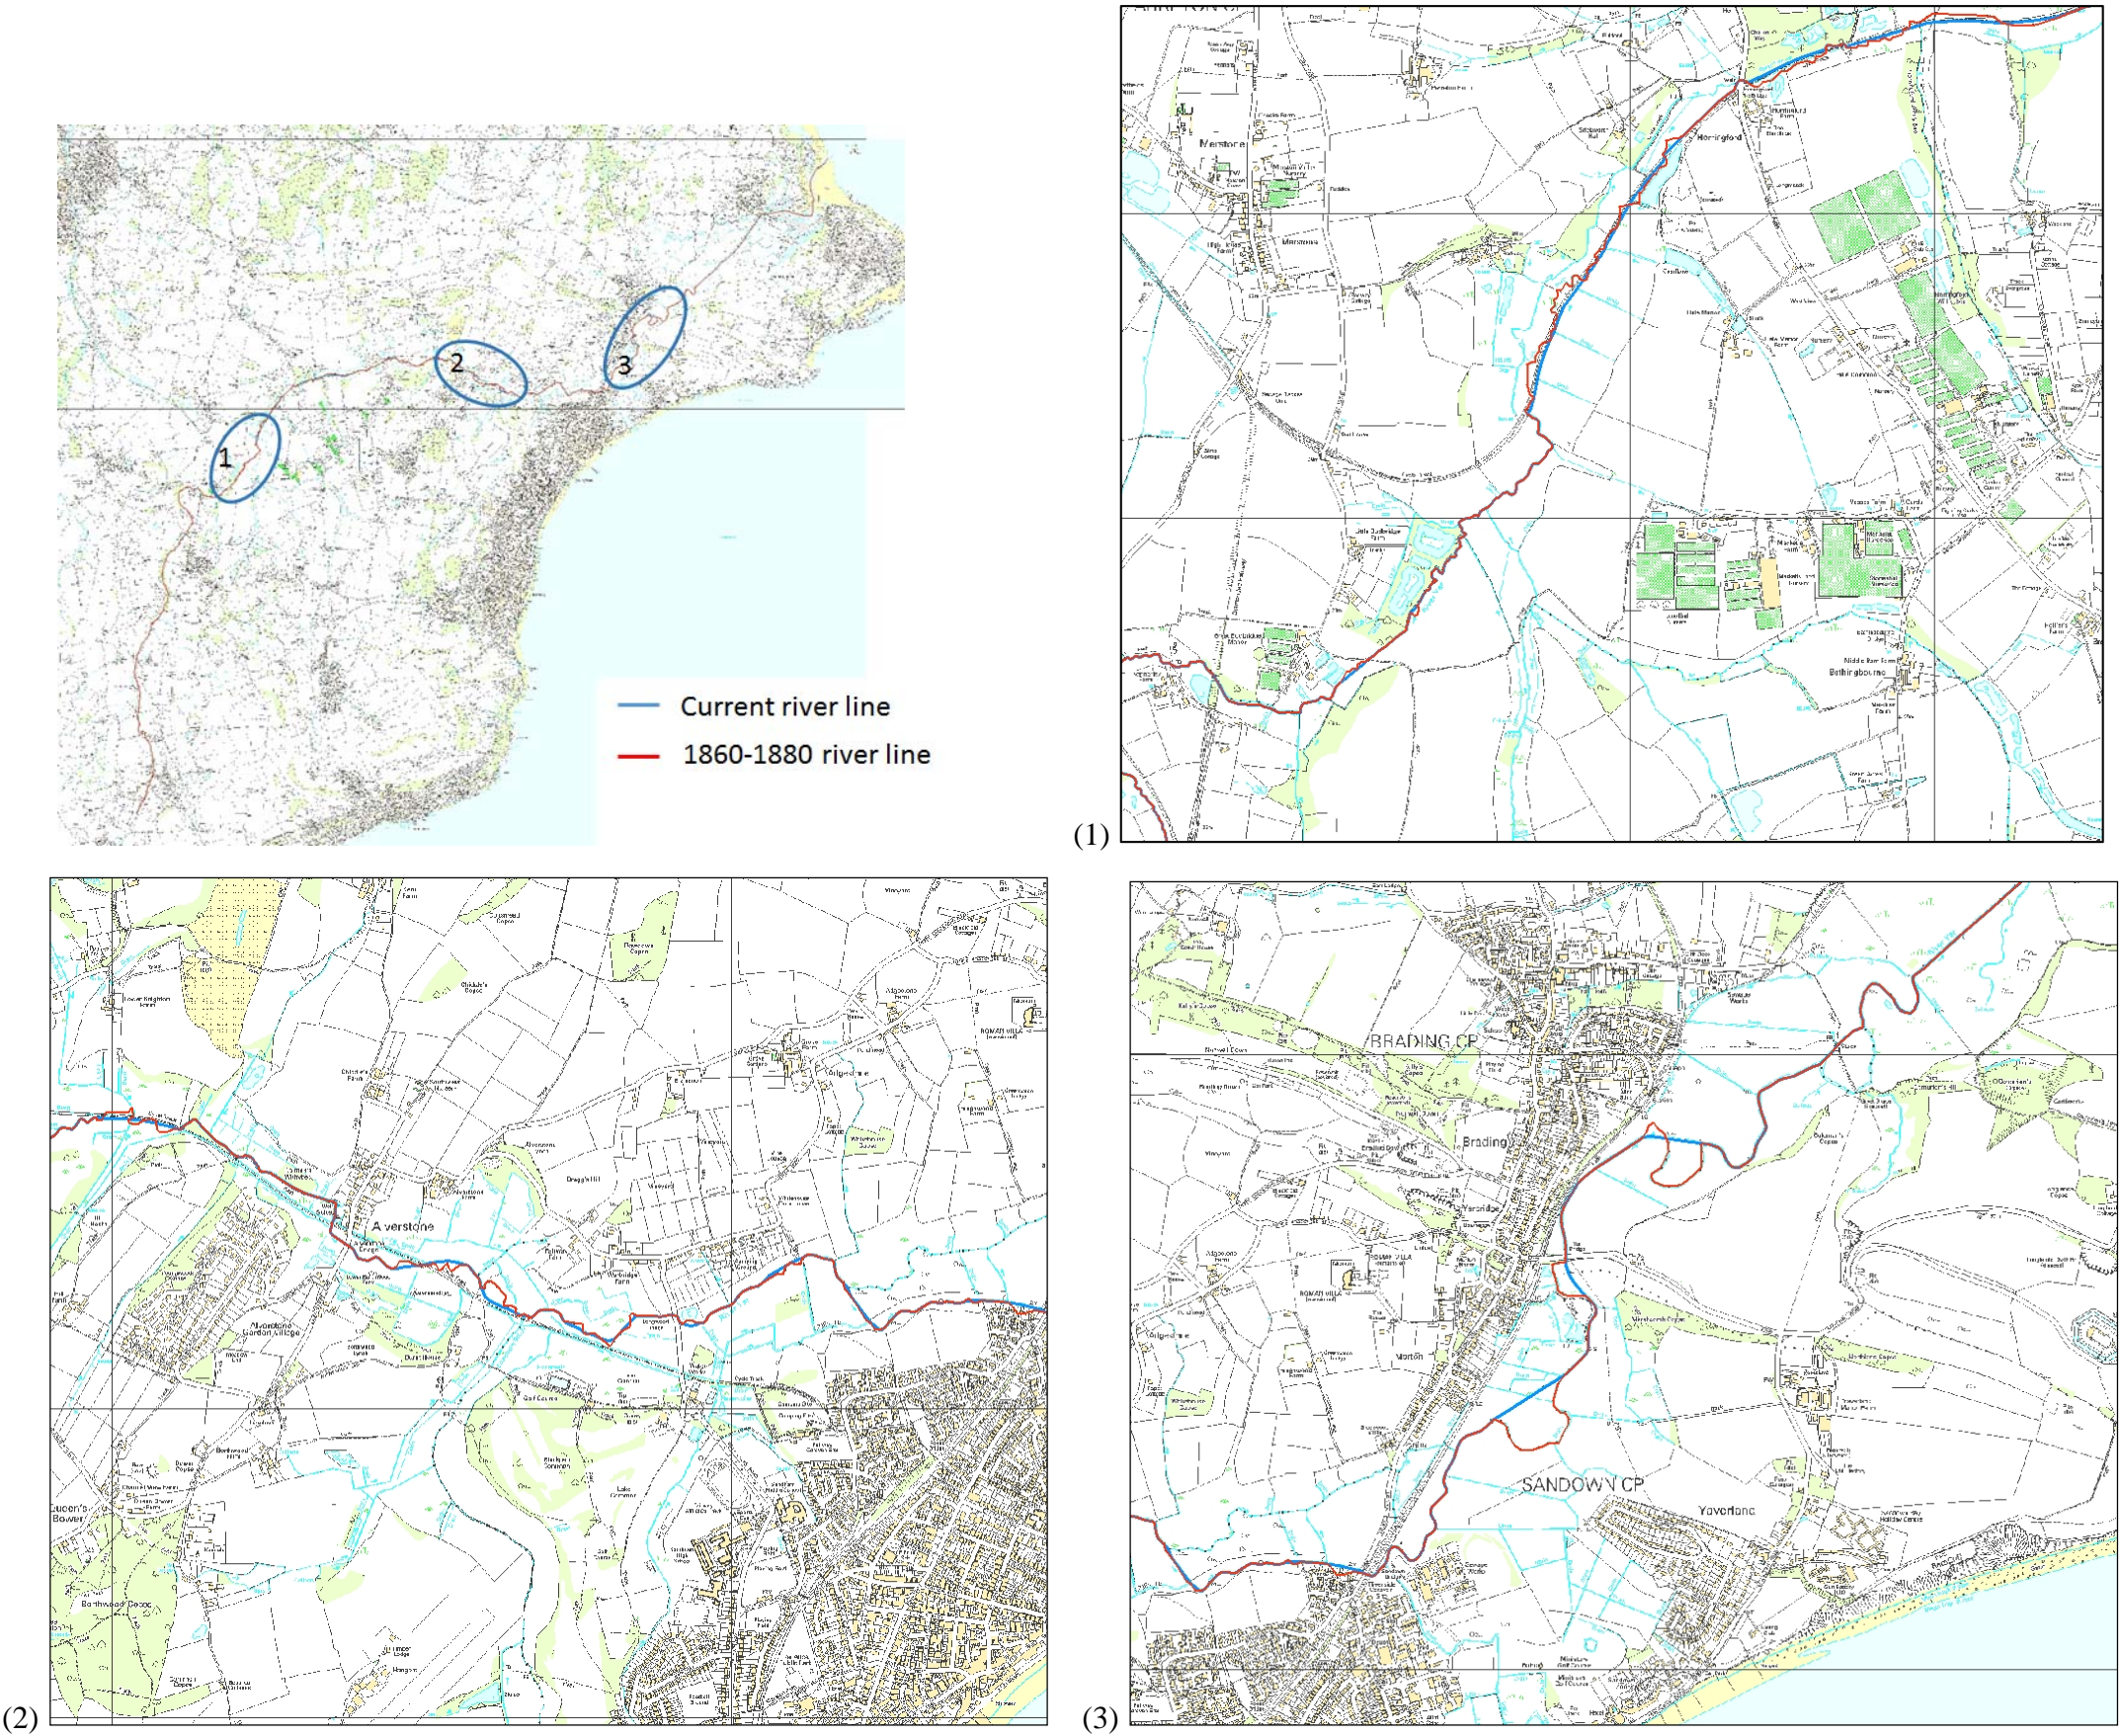
Figure 4: Main watercourse planform changes between 1860/80 and present.

Further straightening throughout the whole catchment took place subsequently, although most of it is concentrated in the central and lower parts, with the main meanders being completely disconnected from a new and straight channel (Figure 5 shows where there is significant deviations between the contemporary and historical planforms). Different episodes of channel straightening have been driven by railway construction in the late 19<sup>th</sup> century and urban and agricultural development and. At the same time, the drainage system was becoming more complex, with a large number of straight ditches aiming to remove water from agricultural fields and floodplains.

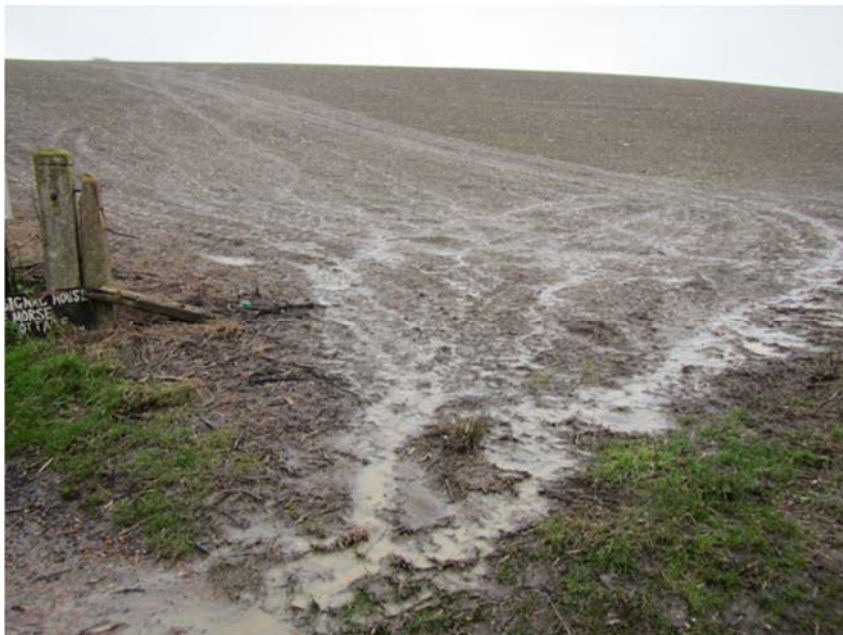
The Eastern Yar catchment is predominantly agricultural, especially in the uplands. It was noted that, during the catchment walkover, surface runoff was observed in many of the agricultural areas of the catchment as illustrated in Figure 6, which shows a relatively newly-sown arable field.

Surface water pathways such as those shown in Figure 6 and discussed in section 6 are present across several areas of the catchment. The geomorphological survey also identified incised, straightened and uniform river channels that are disconnected from their floodplains. These factors increase the volume, as well as the rate at which runoff is delivered to watercourses. Once in the watercourses, floodwater can pass more rapidly downstream than would be the case in an unmodified system. Both of these processes can result in increased risk of flooding in downstream locations.

Figure 6: a) Example of runoff from agricultural field near Niton; b) GIS analysis of topography of area in photo – showing area as prone to surface runoff.

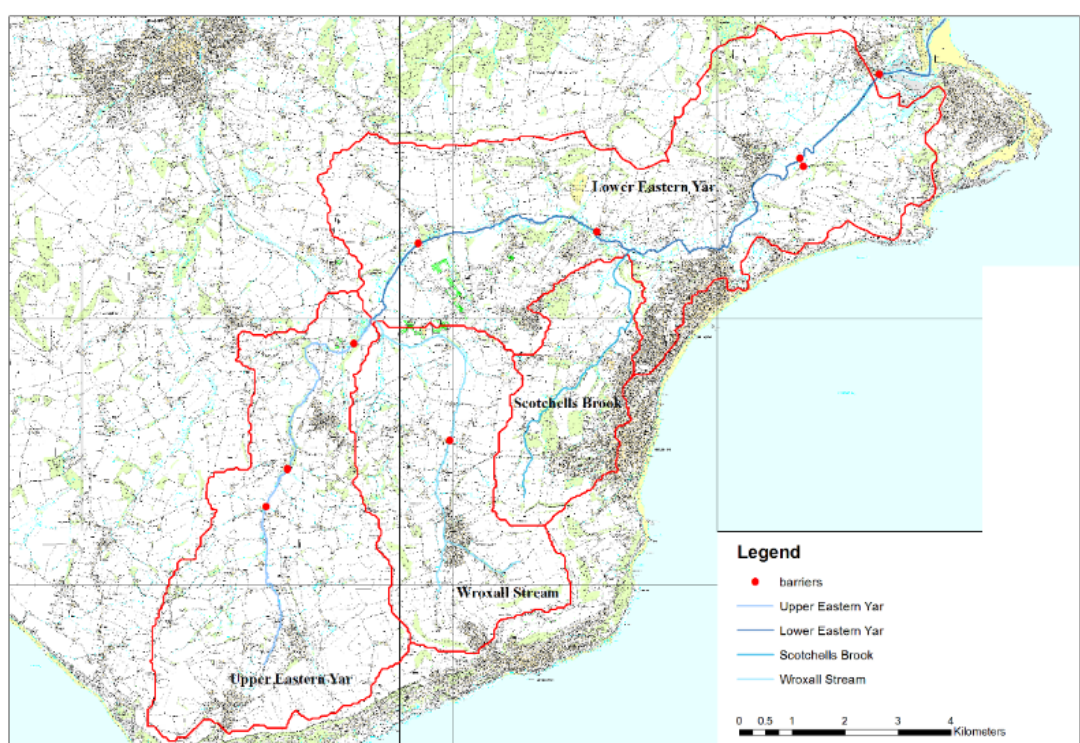
Several barriers have been identified on the geomorphological survey (see Figure 10, Figure 11 and Table 5). Although some of these barriers may be obsolete, others like Budbridge gauging sluice, or the Great Sluice and Bembridge Sluice, are still in use, and any intervention or modification will need to take this into consideration

Figure 10: Main barriers in the Eastern Yar catchment

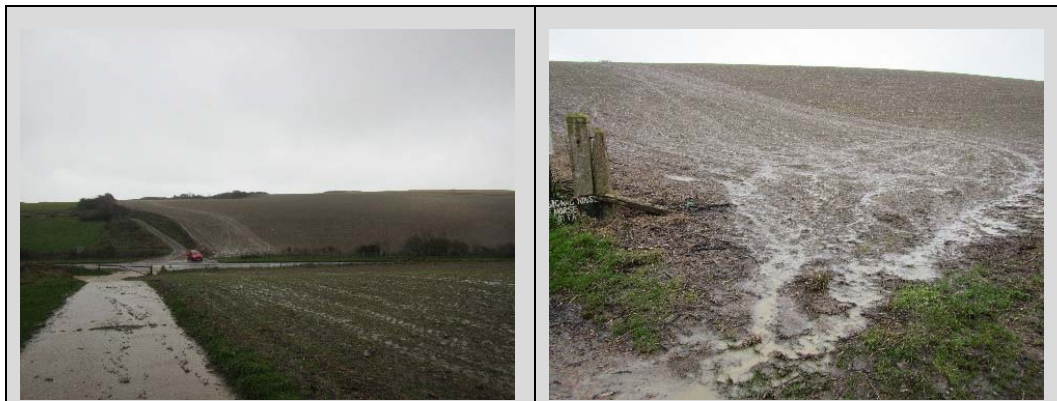
Observations on the agricultural land surrounding this section of the catchment showed surface runoff and sediment erosion on the landscape could be adding stress to this section of the Eastern Yar (e.g. Figure 13 and Figure 14).

Figure 13: Left – Arable fields West of Niton exhibiting flow pathways

Further investigation in this areas would be necessary to assess the potential benefits and specific areas of opportunities for reducing flood risk and excess sediment levels in the Eastern Yar through the implementation of runoff and sediment management measures in this area.

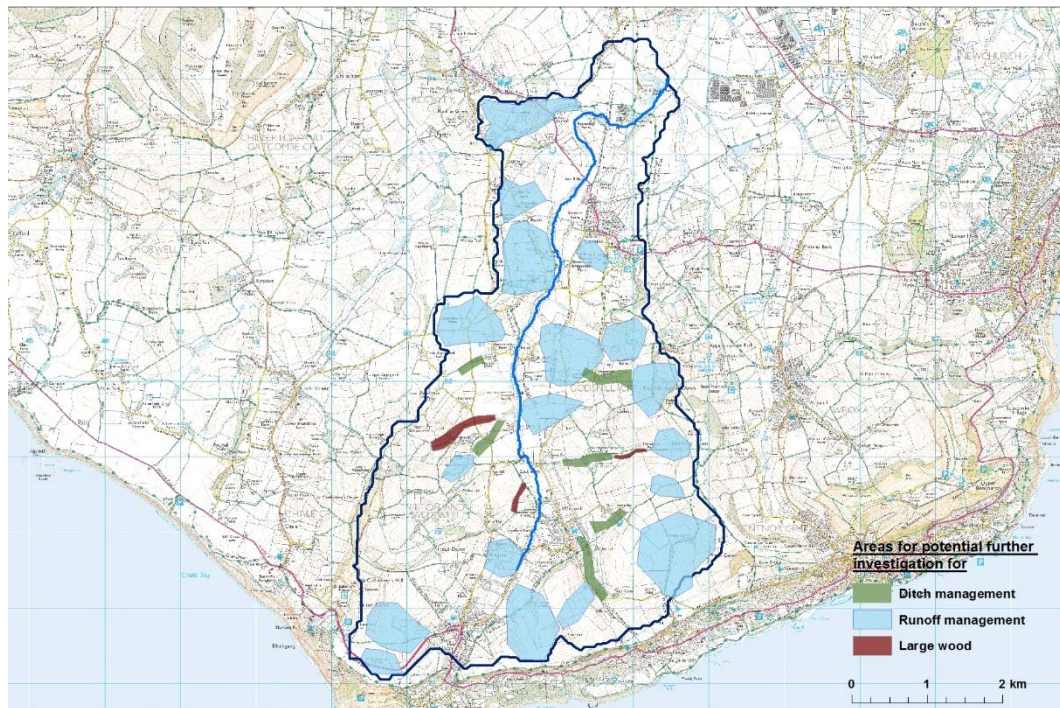
Figure 15: Potential locations of catchment wide solutions for further investigation, Upper Eastern Yar

Potential general areas that could be further investigated as locations for the implementation of runoff management and ditch management techniques are shown in Figure 15. These areas were identified at the desk study and catchment walkover, although more specific feasibility assessments would be required. These actions could provide increased benefits if combined with the use of large woody dams (LWD) at strategic locations in upstream areas of the catchment.

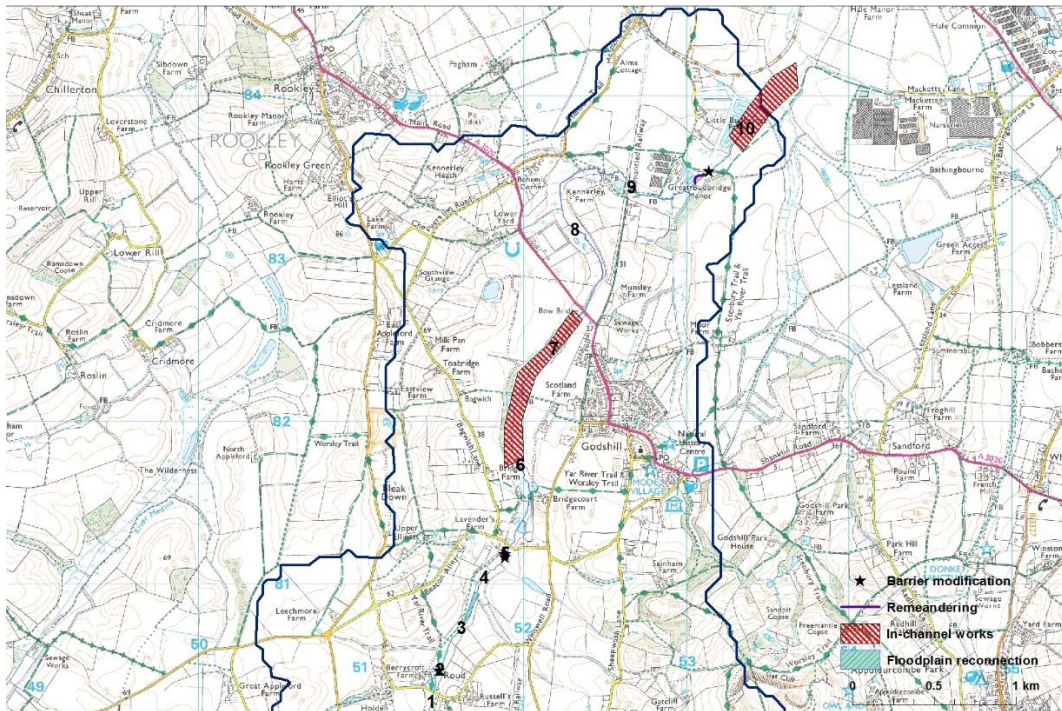
Figure 16: Proposed channel based restoration for the upper Eastern Yar

Figure 16 provides a summary of the restoration options at a sub-catchment level and the following sections provide details of the pressures and solutions at a reach scale.

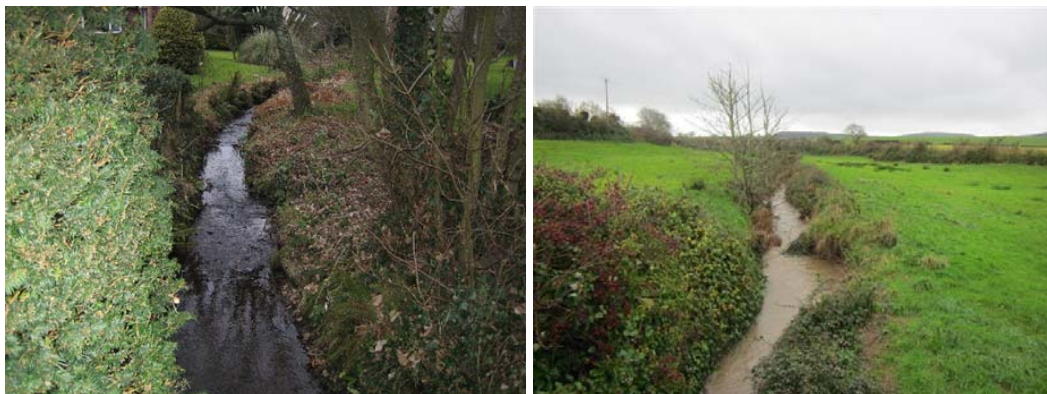
Figure 17: Views of reach 1

The flow is relatively diverse, and signs of both active erosion and deposition processes taking place. Riparian cover is composed mostly of herbaceous vegetation and shrubs, with sparse wooded cover.

Some minor channel straightening has taken place next to Roud STW (less than 30 m long).

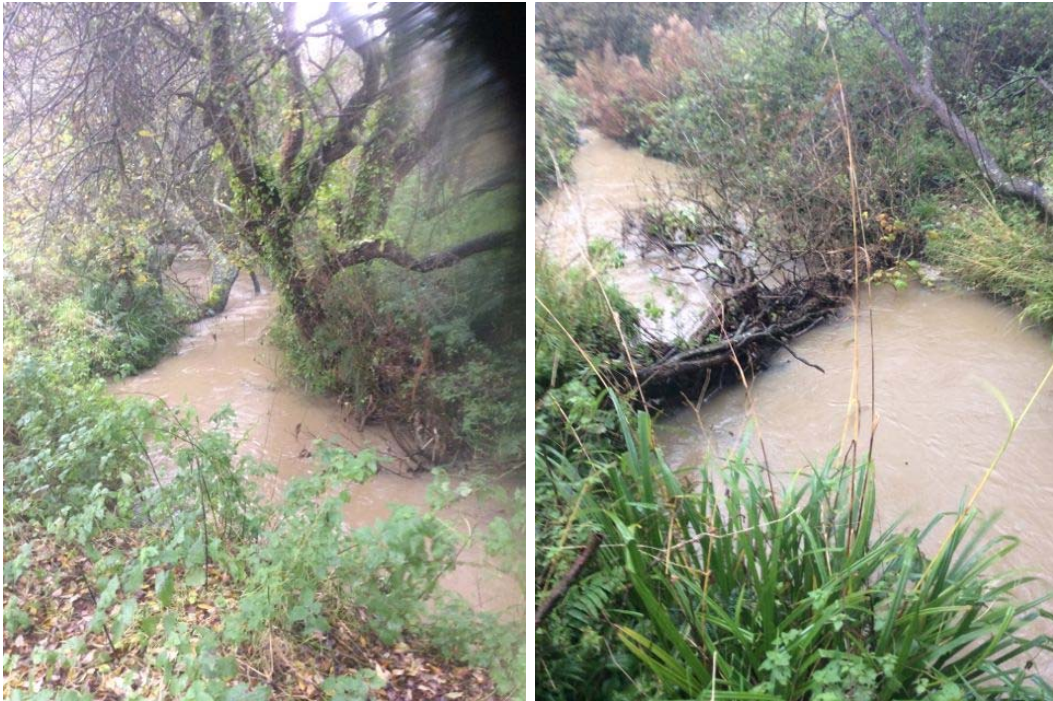
This reach is a sinuous section of the river, with slower flows than those observed in the upstream reaches, suggesting a shallower gradient/longprofile. The channel in this section is fairly trapezoidal in places, with some signs of incision that may be related to historical dredging of the bed. Morphological diversity is also lower than in Reach 2, with predominately runs. There is some large wood in the channel (Figure 12), increasing morphological processes and diversity locally.

There is a 1 m wide drain running parallel to channel in this area. There is evidence of recent out-of-bank episodes in the upstream section of the reach, such as flattened vegetation and saturated land. Steep banks and incision in the lower section lead to disconnection between the channel and its floodplain, which increases as it flows downstream. However, the left floodplain also appears to become easily waterlogged. Marginal habitat become less developed in this reach.

Figure 20 Reach 2 in the upper Eastern Yar.

Reconnecting the channel to the left floodplain by reprofiling the bank at the downstream end of the reach, where it is not used for agriculture purposes, could improve floodplain wetland habitat and contribute to downstream flood risk reduction, while adding some diversity by creating a more asymmetrical cross-section. Details of the potential locations of these actions are shown in Figure 16 and in Appendix E.

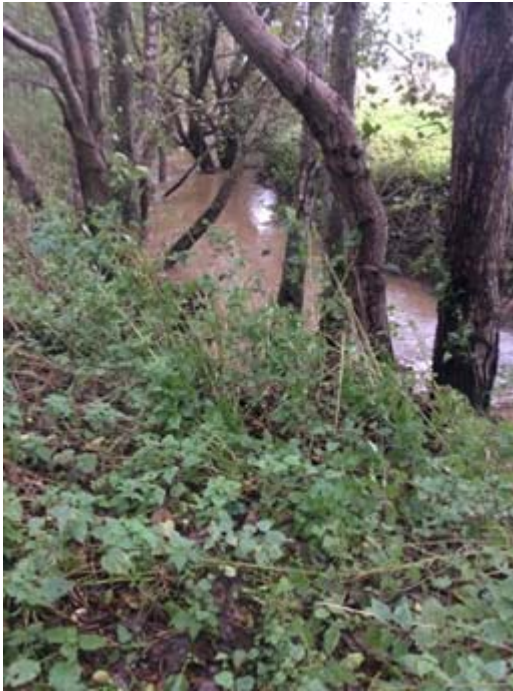
Figure 21: Reach 4

The channel is sinuous and fairly diverse in Reach 4, with erosional and depositional features present. Banks are steep, and composed of cohesive silty and sandy material. The channel is incised and disconnected from its floodplain. There is a dense riparian vegetation cover, composed up to 50% of trees on the left bank, but more open and with sparse tree cover on the right bank.

There is potential for improving the connection to the left bank floodplain on the upstream section of the reach, where there is an area currently covered in rough vegetation, improving both channel morphology and marginal and riparian habitat quality. Details of the potential locations of these actions are shown in Figure 16 and in Appendix E.

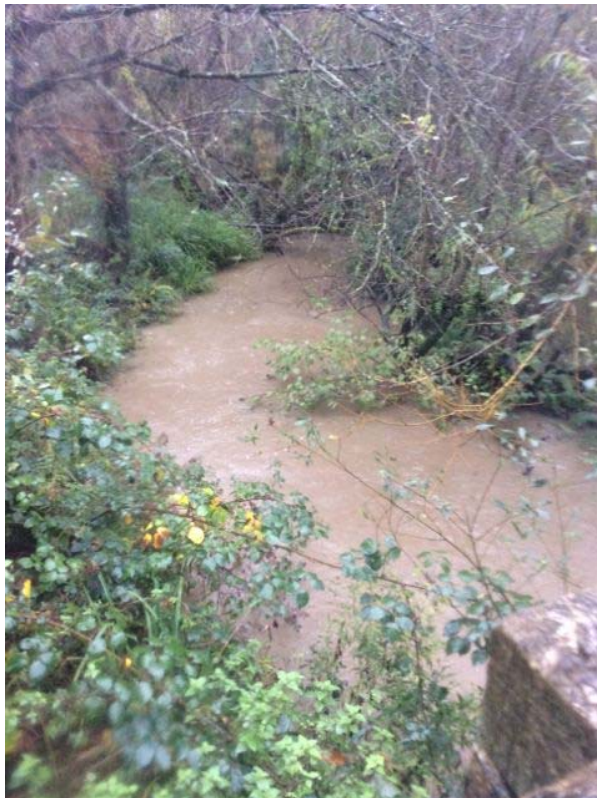
Figure 23: Reach 6

The channel becomes wider (3 m) in this reach, with high and steep banks. Although the planform is fairly sinuous, in-channel morphological diversity is low.

Access to the channel is poor, with dense woody vegetation on both banks, providing a buffer between the channel and arable fields.

In-channel works, including the creation of alternating berms and introduction of flow deflectors to narrow down the low flow channel could aid improvements in geomorphological processes and morphological diversity. Bank re-profiling would provide additional diversity and ensure that channel capacity is maintained.

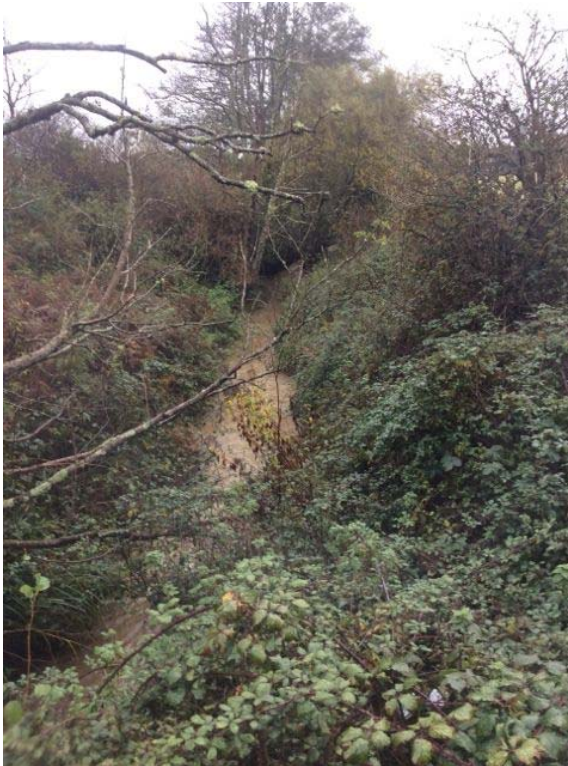
Figure 25: Reach 8

Bow Bridge STW is located at the start of this reach and the left bank is much higher (approximately 4 m) than the right bank (2-2.5 m). There is some morphological and flow diversity in the channel.

The banks are heavily vegetated with shrubs and trees, which are encroaching the channel in places and as such vegetation management may be needed in this section. No significant opportunities for in-channel improvements were identified.

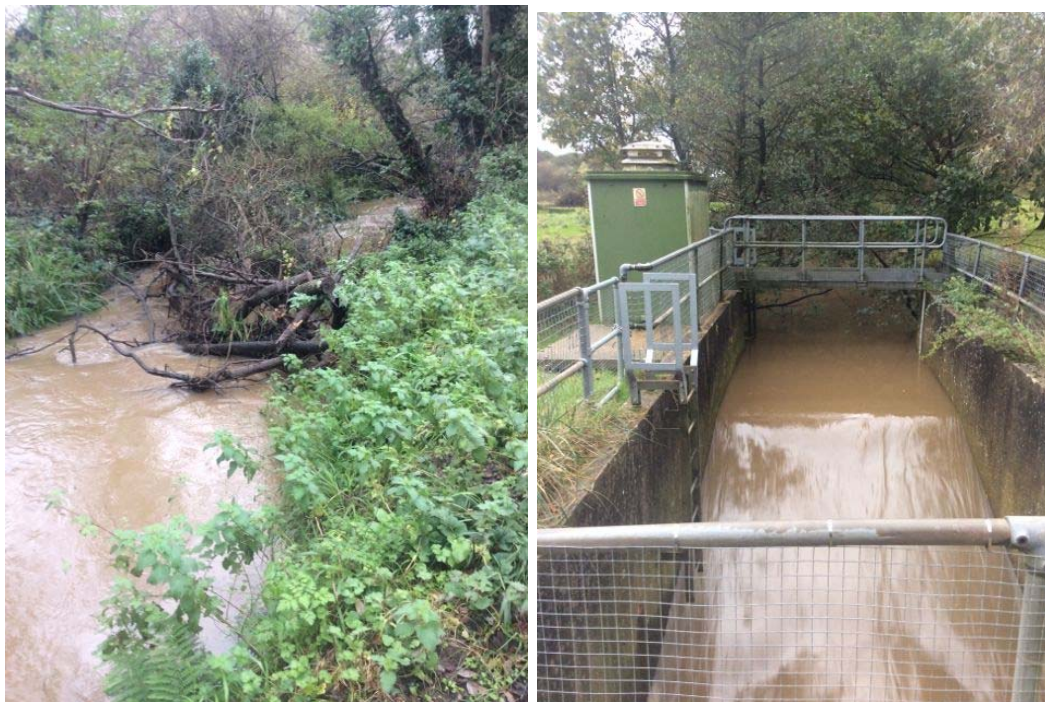
Banks are much lower in this reach on average (approximately 1.5 m), and sloping in places, although the left bank is more vertical in general and there is evidence of fluvial erosion and channel failure.

There are fewer trees on the banks, with riparian vegetation dominated by shrubs and tall grasses. Large wood was observed in the channel, appearing to having been placed deliberately (potentially to slow down flow) at a section not located near productive land

Figure 26: Reach 9 and gauging station.

Budbridge gauging station is located at the downstream end of the reach. This is a functioning hydrometric monitoring station<sup>4</sup> that is currently a barrier to fish passage. Any improvements to fish passage would need to consider that this is a functioning hydrometric monitoring station<sup>5</sup>. There are also some ponds, created in the 20<sup>th</sup> century on the left floodplain in the vicinity of the gauging station, potentially related to disused greenhouse infrastructure at Budbridge Manor.

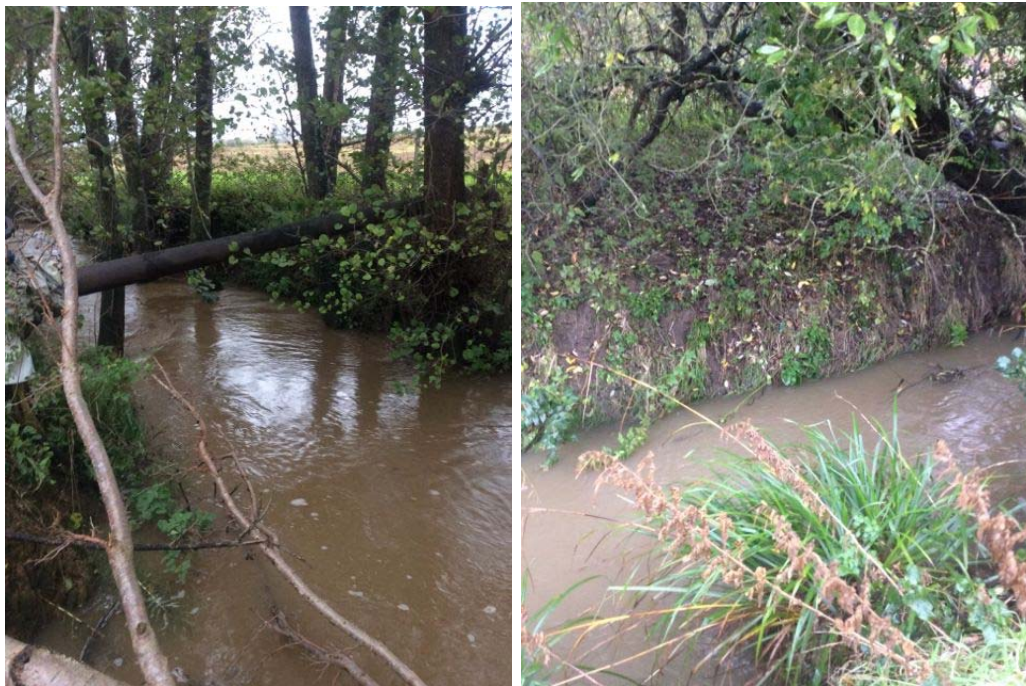
Figure 27: Reach 10

A sharp meander was disconnected in this section in the past creating a straightened section which was shortened to a third of the original length (from 100 m to 35 m). Some fishing ponds have been created on the left floodplain in the 20<sup>th</sup> century. The site of the original channel is now productive arable land with a small wooded buffer area adjacent to the channel. These factors may cause complications if reconnection was desirable, especially if the land is of high productivity. As an alternative, there may be potential for in-channel works to narrow low flow channel and reprofile the banks to improve channel morphological and improve habitats locally.

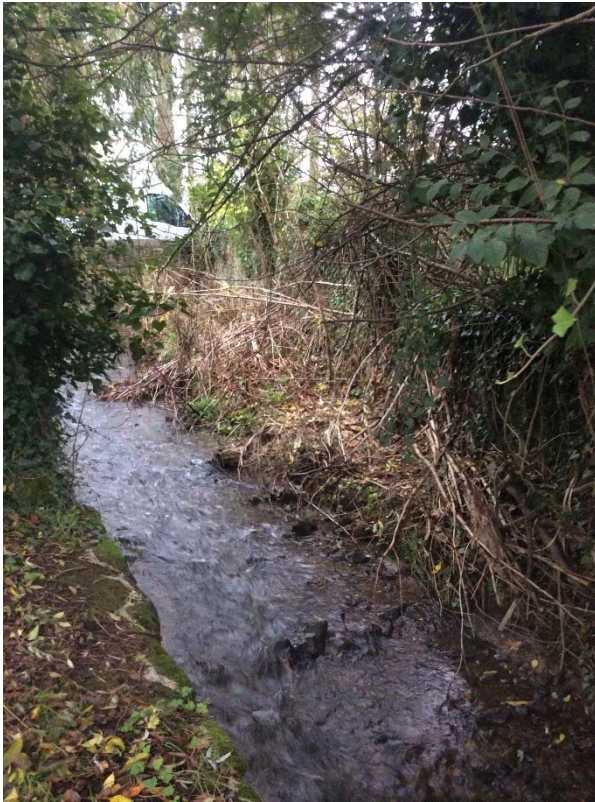
Figure 31: Wroxall Stream, upstream section

The channel has a fairly natural bed in the upstream section. The main channel modifications are found adjacent to developed areas, with artificial banks used mostly for flood protection purposes, and significant culverting through Wroxall itself as a result of its urbanisation in the 20<sup>th</sup> century. Floodplain connectivity is generally low as a result of the aforementioned bank protection, although there is some connection where the stream drains agricultural land.

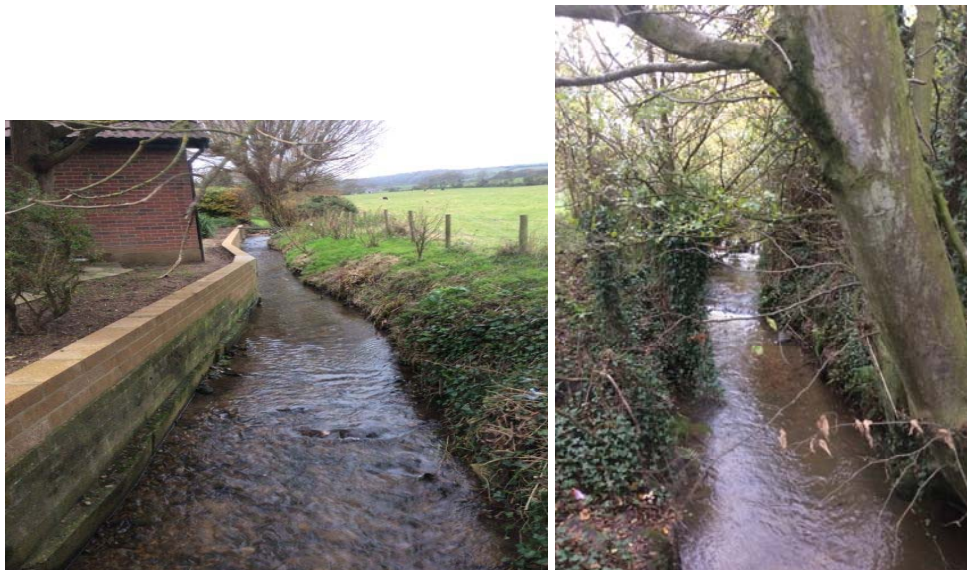
Figure 32: Wroxall Stream, middle section and weirs upstream A3020.

There is bank protection related to built-up areas, limiting the opportunity to increase floodplain connectivity. There are two small weirs upstream of A3020 road bridge. The purpose of the structures is unknown.

In-channel works using existing material present within the channel could provide benefits to this area by increasing diversity where it is poor.

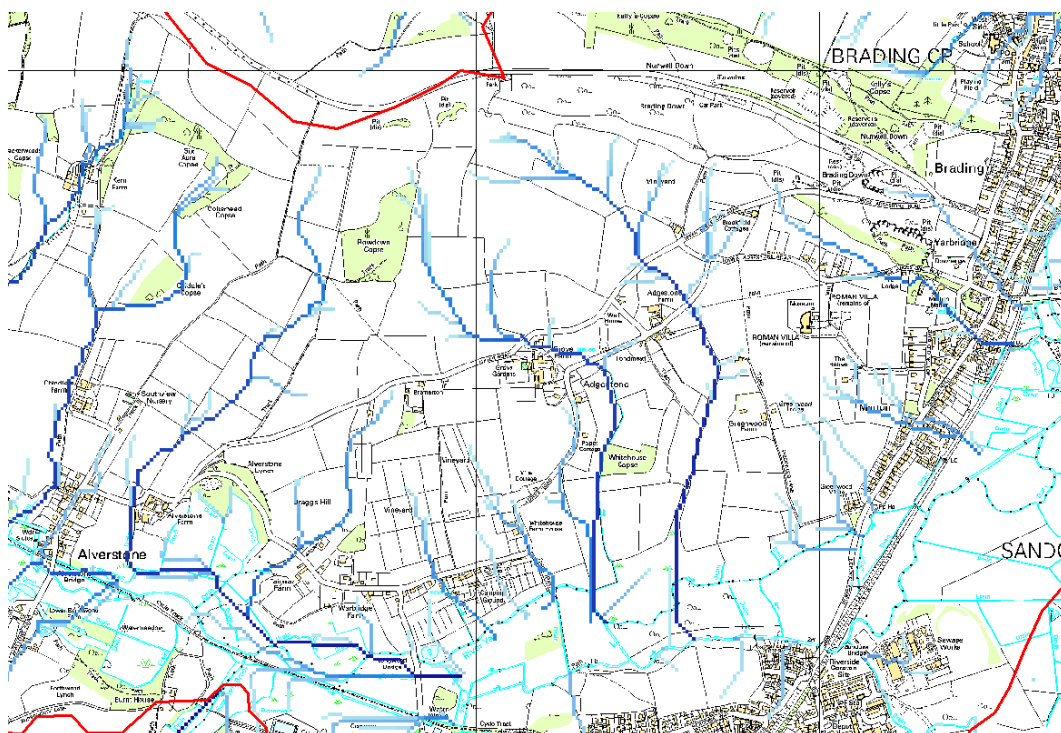
Figure 40: Screen shot of GIS output showing the runoff pathways detected in the topographic analysis

According to sources in the stakeholder workshop, most of the runoff with potential to deliver significant amounts of water and sediment into the water body can be observed in the northern part of the sub-catchment. This area has also been identified in the GIS analysis as having great potential for surface water runoff due to the steep valley sides of this part of the catchment (see Figure 40). The majority of the catchment walkover in this sub-catchment was based in the Brading Marshes to assess the potential for reconnecting the river with the surrounding floodplain.

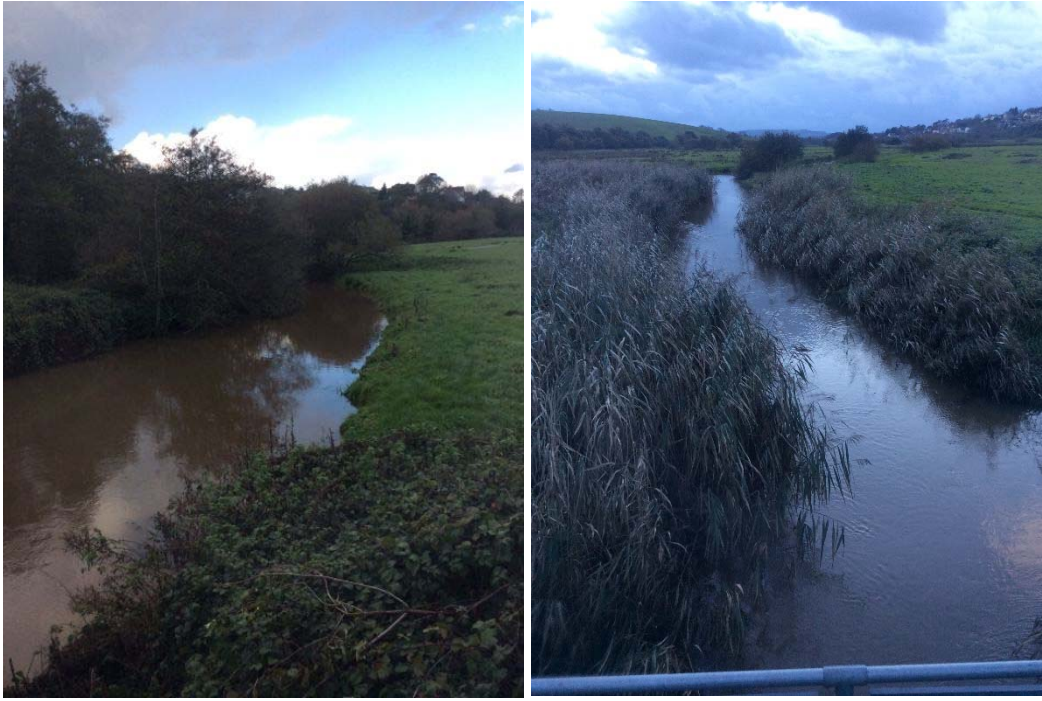
Figure 42: Reach 17

This reach runs along the railway at the upstream end. The channel is trapezoidal, with little in-channel diversity. There are significant wet areas on the floodplain, mainly in the lower section of the reach. Vegetation cover is sparse on the right bank in the upstream section, with denser wooded vegetation between the railway and the channel on the left. Bank vegetation is mostly herbaceous further downstream, with a significant presence of marginal reeds.

The sluices at the downstream end of the reach are the main water level control structures, required to maintain appropriate levels for conservation and flood protection purposes. These structures pose significant barriers to longitudinal connectivity and fish migration. Any modifications to improve fish passage would need to be integrated with the structure use it.

There is a section where a meandering section has been straightened and there is good potential for reconnecting this historical meander to the main channel. In addition, steep banks could be modified to improve lateral connectivity with the floodplain. The locations of these opportunities are shown in Figure 34 and Appendix E.

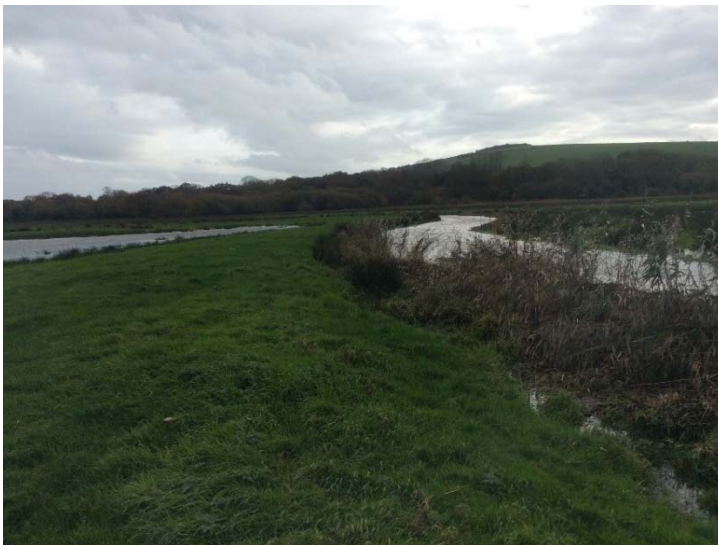
Figure 43: Reach 18 (right) and wetland area (left)

The channel in this reach in Brading Marshes Nature Reserve is mostly trapezoidal, with little in-channel diversity. The channel is incised and dredged material has been deposited to create an embankment along the banks, creating a disconnection between the channel and the floodplain. Some bank failure was observed. There are significant wet areas in the reach. Riparian vegetation is predominantly herbaceous, with some marginal reeds.

There is an historical meandering section that has been straightened and shortened to half of its original length. There is good potential for reconnecting this historical meander and removing the embankments and reprofile the banks to improve lateral connectivity and morphological diversity. Figure 34 (and Appendix E) show the location of this feature and the possible solutions in this reach.

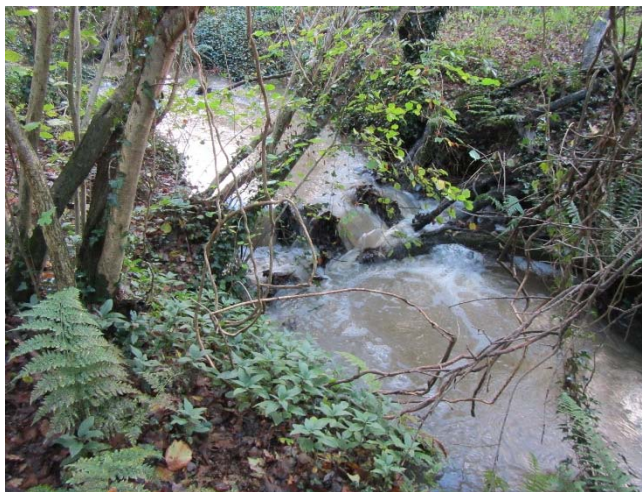
Figure 48: Scotchells Brook, upstream section

The upstream section of Scotchells Brook is relatively high energy, with significant wooded areas providing large wood to the channel. The planform is fairly natural and there is in-channel variability which is more limited towards the downstream end of the reach, where the channel becomes more trapezoidal.

There is potential for some minor in channel intervention in this reach to increase morphological and flow diversity, with introduction of flow deflectors and/or redistribution of existing material.

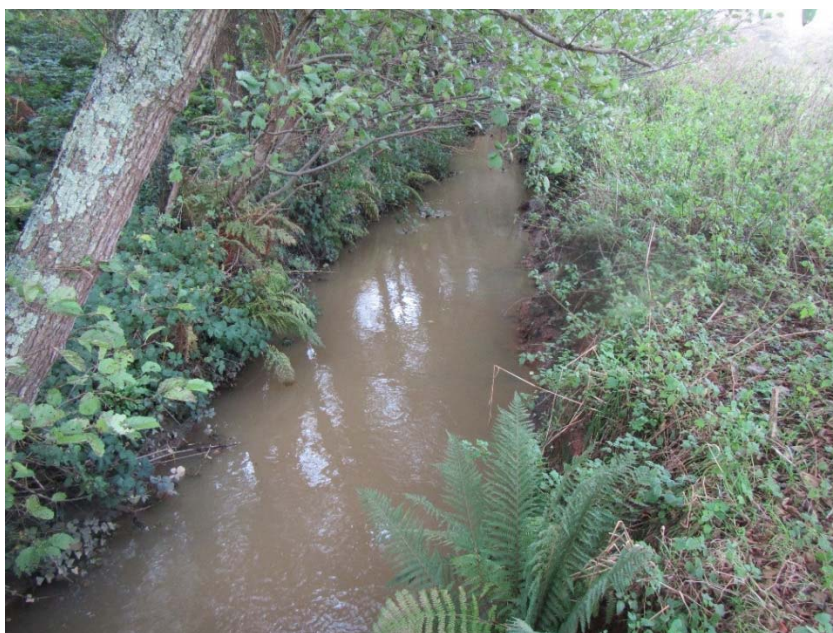
Figure 49: Scotchells Brook, middle section

The channel becomes clearly incised in this reach with little morphological and flow diversity and poor connectivity to the floodplain. Due to the uniformity of the channel, there is little process variability in the system. Siltation is significant in the channel, both on the bed and as suspended material.

In-channel works, including bank reprofiling where possible, could contribute to improve system diversity and provide better quality habitats. Appropriate feasibility would need to be undertaken to identify specific locations for such improvements. Any actions would have to be integrated with invasive plant species management actions.

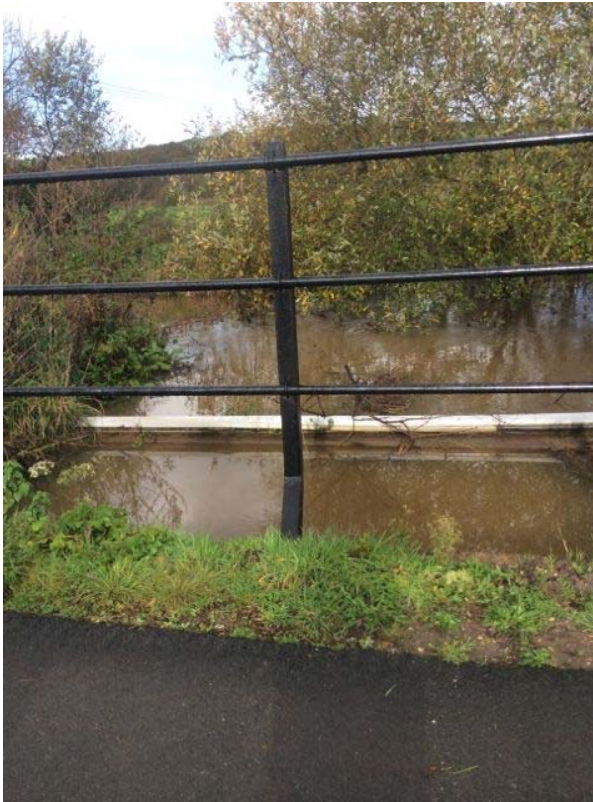
Figure 50: Scotchells Brook, upstream of confluence with Eastern Yar

The channel is uniform with low morphological diversity and poor connectivity to the floodplain, as dredged material has been deposited to create an embankment along the banks. The brook follows more or less same line as 1860, with slightly less irregular sinuosity. The flow of the brook is slackened noticeably due to a locking effect from the confluence with the Yar and siltation levels are high.

Reconnecting the channel to its floodplain would contribute to improved riparian wetland habitat. Improvements to in channel diversity and cross-sectional form to create a more asymmetrical in shape, which would promote more dynamics processes to take place within this reach.
